AVIATION INVESTIGATION REPORT

A04C0064

IN-FLIGHT BREAKUP / COLLISION WITH TERRAIN

BABY BELLE (HELICOPTER-AMATEUR BUILT) C-FZQN

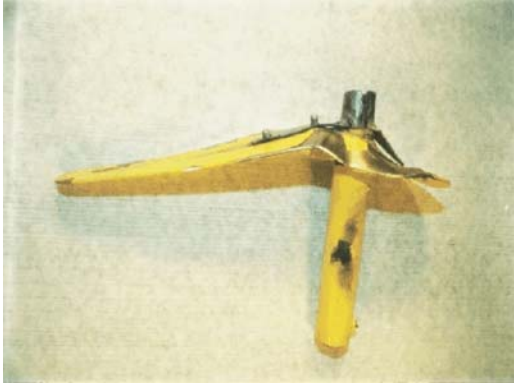
Photo 1. Horizontal stabilizer attachment structure and spar section

The horizontal stabilizer attachment structure found at the site was equipped with an aluminum end cap that was mounted against the airfoil at the root end (see Photos 1 and 2). A review of the construction drawings and a discussion with the kit manufacturer, revealed that the stabilizer is equipped with an end cap on the outboard end of the airfoil and is not designed with an end cap at the root end.

1. Installation of the end cap at the root end of the stabilizer spar hid the fatigue crack.

The manufacturer of the Baby Belle kit has issued a technical bulletin informing operators of the occurrence and of the recommended inspection criteria. The bulletin also advises operators to comply with the design by removing the end cap, if installed, at the root end.

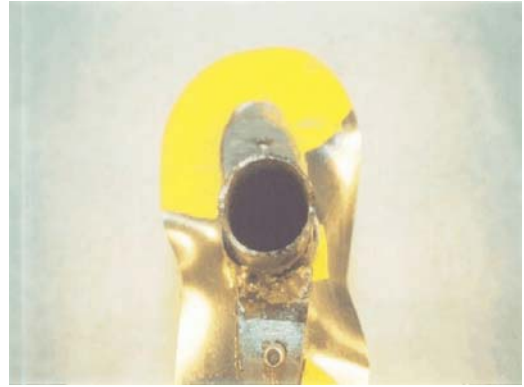
Photo 2. Horizontal stabilizer spar fracture

The tail-rotor blade separation that occurred previous to the accident flight caused the horizontal stabilizer spar to bend. The spar was subsequently bent back and cold straightened using a press. This process for straightening a tubular horizontal stabilizer spar is not a recommended maintenance practice. No record of the spar repair was found in the aircraft maintenance records.

The separation of the horizontal stabilizer during the accident flight is probably related to the previous separation of the tail-rotor blade and its subsequent repair. The separation of the tail-rotor blade induced an excessive amount of vibration in the stabilizer that, when combined with the 22-inch arm of the airfoil, bent the stabilizer spar at the root end. The repair, in which the stabilizer spar was bent back and cold straightened, in combination with the excessive vibration, would concentrate forces at the first rivet hole of the root end. The subsequent two tail-rotor strikes then would have aggravated the localized stress concentrations. The vibrations induced by the tail-rotor blade separation and tail-rotor strikes initiated fatigue cracking. Continued operation of the helicopter resulted in continued fatigue cracking and in the eventual overload failure of the stabilizer spar. Installation of the aluminum end cap at the root of the horizontal stabilizer airfoil did not allow inspection of the area, effectively hiding the fatigue crack.

1. Separation of the tail-rotor blade during a previous flight had induced an excessive amount of vibration in the stabilizer, resulting in bending of the horizontal stabilizer spar.
2. Cold straightening the stabilizer spar, which was not a recommended maintenance practice, concentrated stresses at the first rivet hole, resulting in fatigue cracking. Subsequent tail-rotor strikes aggravated localized stress concentrations.

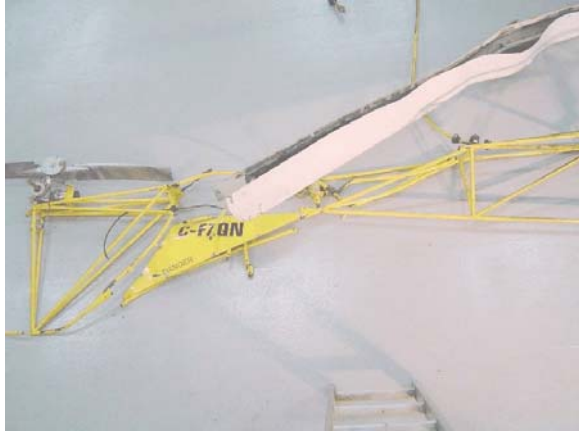
the main rotor blades down, resulting in tail structure interference with the main rotor disc (see Photos 3 and 4). Continued rotation and mast bumping of the main rotor blades destroyed the bubble canopy, and caused the in-flight break up of the helicopter. It is likely that during ground impact the forward protruding rotor blade was forced up, resulting in an overload failure of the rotor spar.

Photo 3. Wreckage reconstruction showing interference of tail boom with rotor

3. Separation of the horizontal stabilizer resulted in a loss of control and in a sudden upward pitch of the tail boom, resulting in the bending of the rotor blades, and causing interference of the tail-boom structure with the rotor disc.

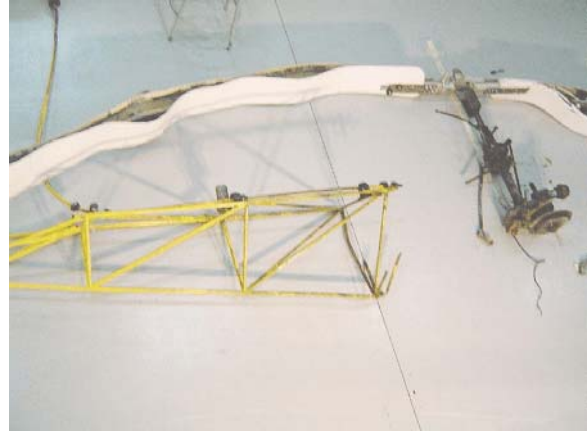
Photo 4. All components situated relative to normal positions on type

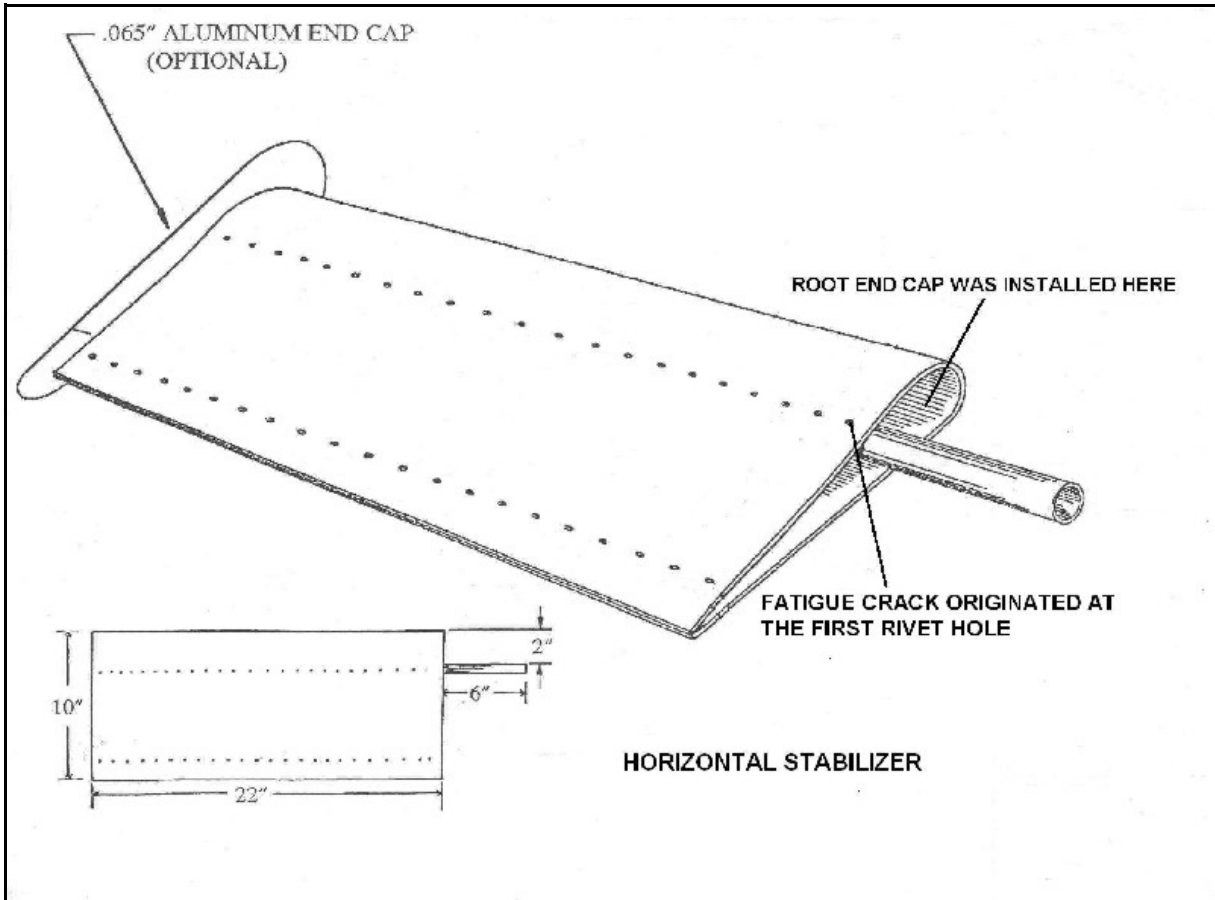
Appendix A - Diagram of Horizontal Stabilizer

The horizontal stabilizer is a 22-inch long symmetrical airfoil mounted with a 2-degree positive angle of incidence, opposite the tail rotor at station 241(see Appendix A). The horizontal stabilizer is constructed of 4130-steel spar tubing and has holes drilled through it for attaching the airfoil with rivets. In forward cruise flight, the stabilizer aids in controlling the helicopter. At speeds below 70 mph, the stabilizer lifts the tail. At speeds above 70 mph, it forces the tail downward. At speeds above 70 mph, the slipstream acts upon the bubble canopy, pitching the nose down and the tail up. As the tail pitches up, the top surface of the horizontal airfoil engages with the slipstream, resulting in a downward force to achieve an equilibrium. The stabilizer also dampens vibrations caused by the tail rotor.
